B. SURVEY SUMMARY OF EXISTING CONDITIONS

EXTERIOR SURVEY

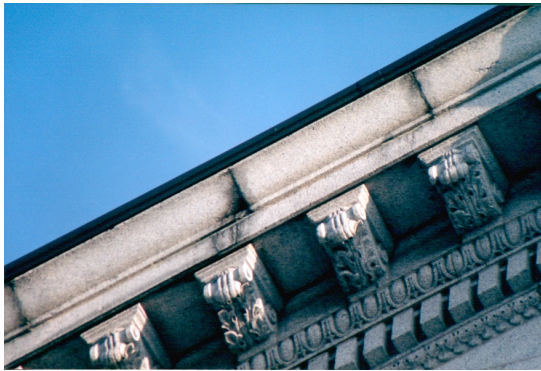
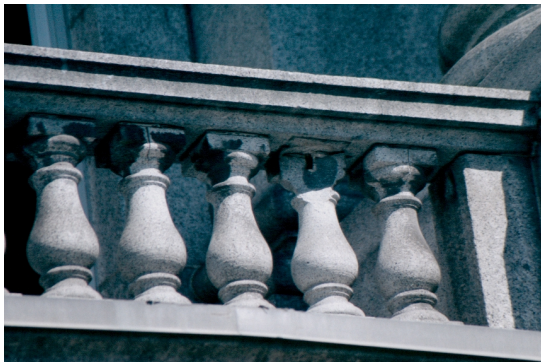
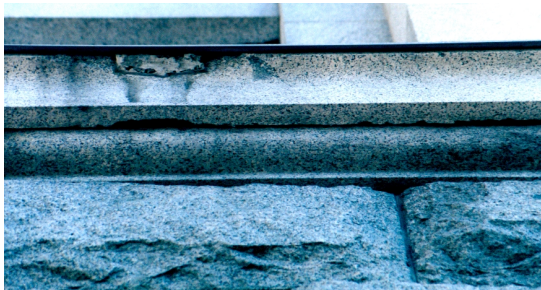
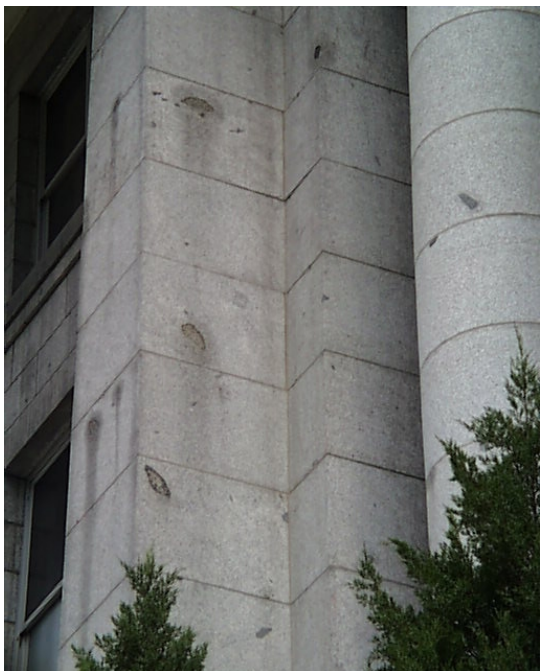
Exterior granite on the capitol is generally in excellent condition for its age. However, there are several conditions which require attention and even destructive exploration to determine extent of damage and develop an approach to restoration and maintenance.

A number of mortar joints are missing or are broken. In some cases these have been inappropriately patched with caulk, especially at windows. In most cases, the vacancy left by the mortar allows water to penetrate the surface of the stone facing, and causes much of the staining, visible both at the joint itself and across the surface of the stone. There are dark stains underneath the cornice, which may be caused by pollution, or conversely, by the oxidization of metal ties holding the ornament on. Efflorescence, white saline stains on the surface of a stone, indicate water penetration with no recourse for drainage. The water then evaporates through the surface of the stone, leaving salt deposits behind. Over time, this will cause spalling of the stone surface, and result in even more water penetration.

There is staining of these varieties on the underneath of almost all aperture openings, as well as under entablatures, protruding belt courses, and the ceilings of the soffit.

Other serious granite conditions include deeply exfoliated surfaces at the south entrance. These are presumably the result of direct impact. All exterior stairs have extensive breaks and chips from normal use. Broken balusters at the main and parapet levels are more difficult to damage by impact, because there is no pedestrian traffic at either of these locations. Breakage is occurring from weathering and insufficient protection from that weather. The damage is from the inside-out, and worsens the longer it is left unattended.

Ornament which is broken and chipped at its corners exhibits additional evidence of poor weather-proofing, and likely also indicates impact by falling ice.

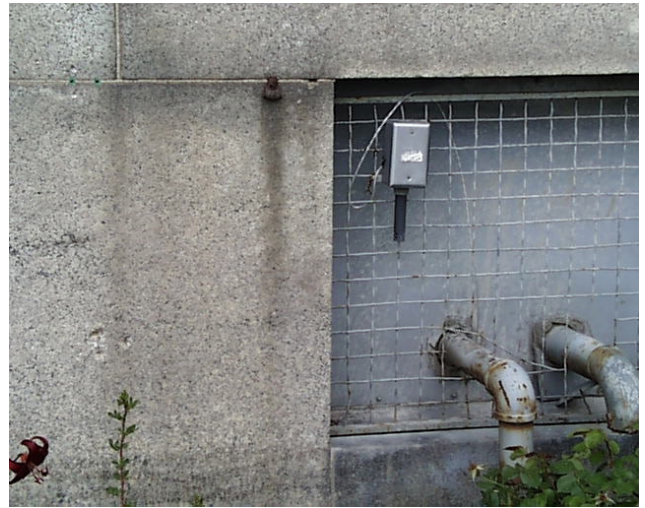
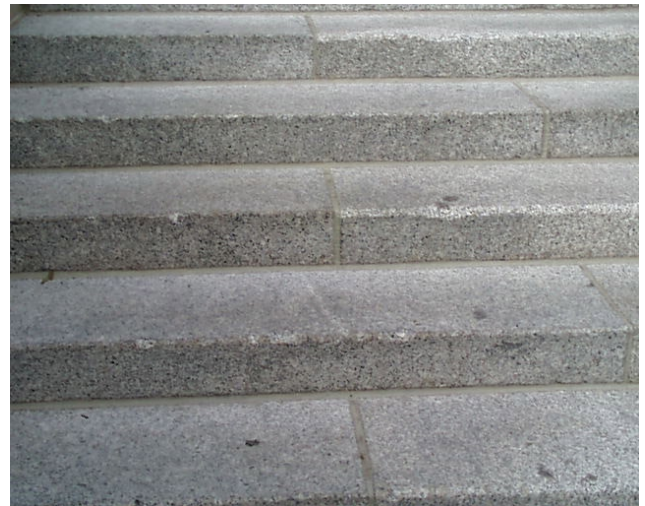
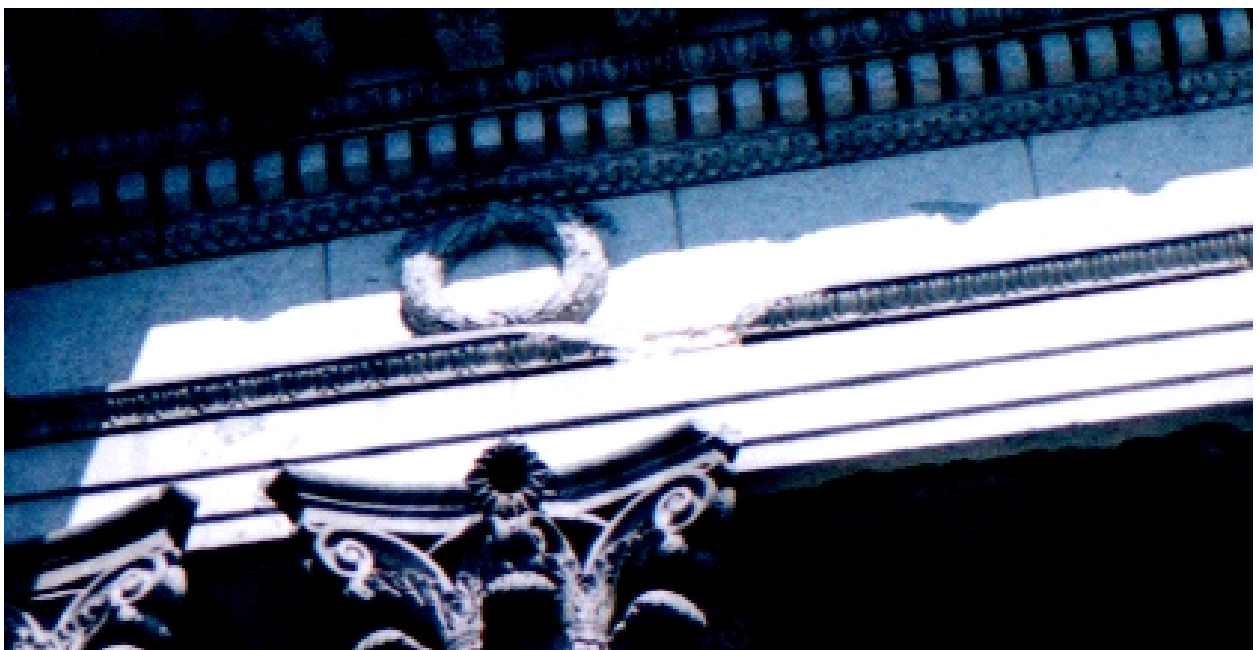
There are many elements which are insensitive to the historic quality of the building and its materials. Light fixtures, screens in basement window openings, plastic and metal anchors placed for temporary support of long-gone items, and other systems items attached to the granite should be avoided when possible. When absolutely necessary, they should always be of a character respecting the historic qualities of the building and causing no damage which is irreversible.

Empty square light casings in the soffit of the main colonnade are removable with little or no damage to the structure, and should be replaced with lighting that is both functioning and retains historic integrity.

Guard rails at the exterior stairs are rusted and their connections to the stone are tentative. These should be replaced with as little damage to the stone as possible in their anchoring.
